GEOTECHNICAL INTERPRETIVE REPORT

MIRA MAR LANDSLIDE

**SLEEMAN AVE AND ANZAC ROAD MIRA MAR
WESTERN AUSTRALIA**

PER2021-0347AM

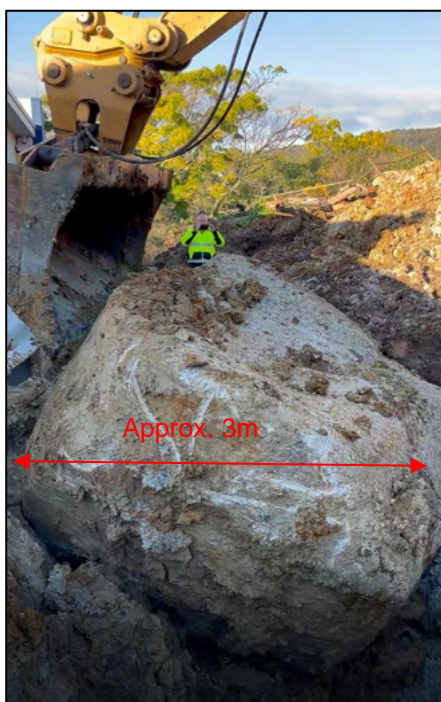
For example, some boulders are approximately 3 m x 2 m x 1 m (i.e. 6 m³ approx. 15 tonnes). Thus, it is considered likely that the boulders are the product of past higher elevation hillslope processes (landsliding) affecting a greater part of the overall hillside than the current landslide area.

Plate 1: Granite boulder removed from behind 7B Anzac Street

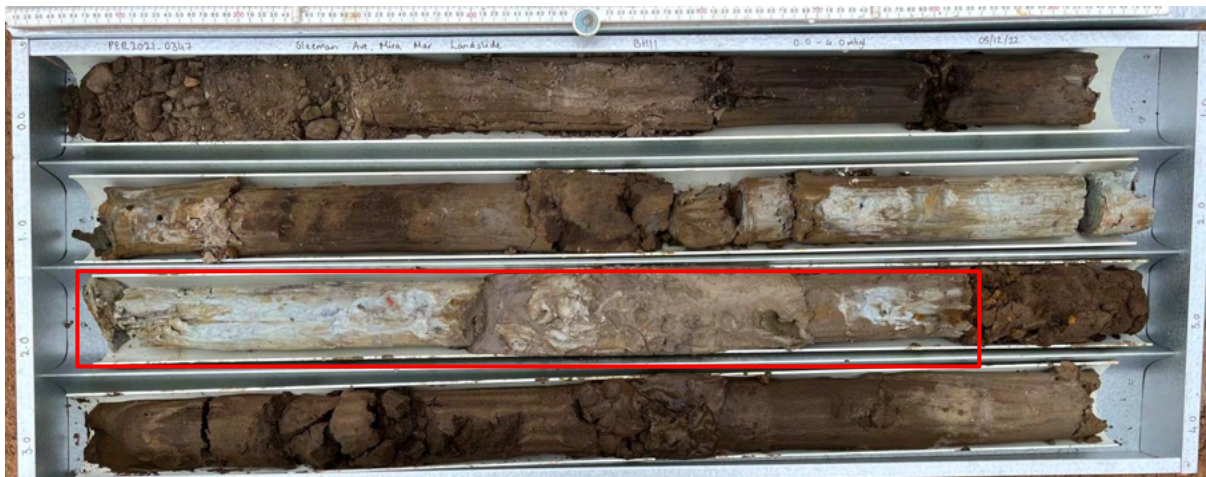
Sand lenses were present in BH11, drilled near the base of the landslide headscarp. It is possible this sand was washed into fissures and voids created by the 2021 landslide and earlier landsliding.

Plate 3: BH11, saturated sand lenses present within the colluvial material.

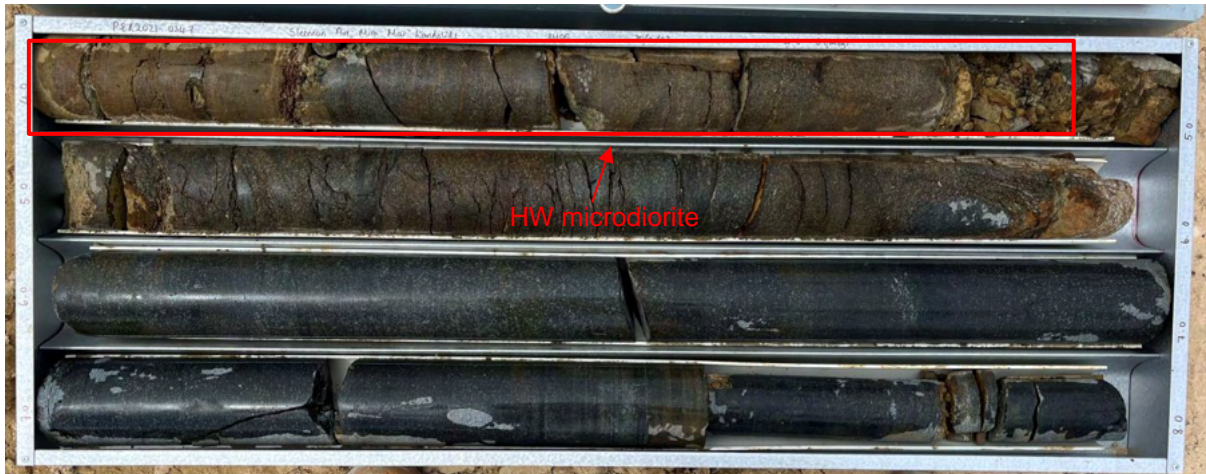
The highly weathered part of the rock profile of the microdiorite is generally fractured and becomes less fractured with depth.

Plate 4: Highly weathered microdiorite transitioning to slightly weathered

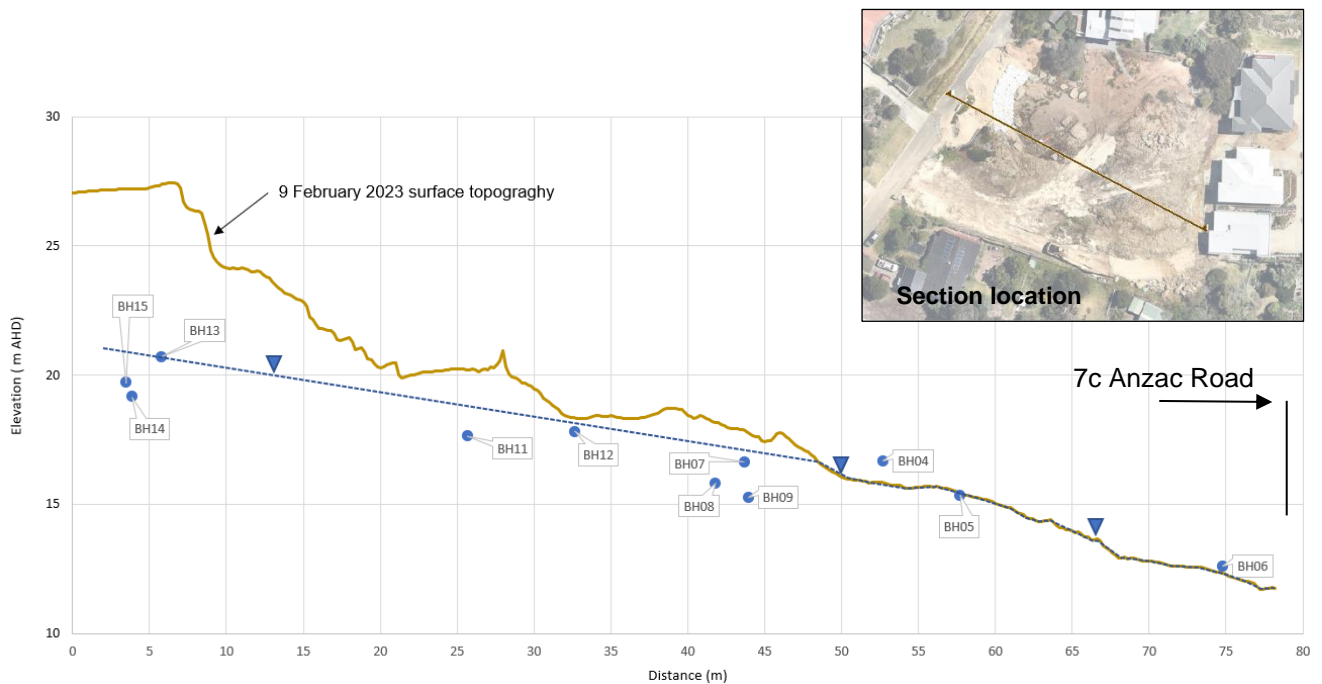
Measured groundwater elevations are reported in Table 8. Ground water has only been measured since January 2023 and as such higher ground water elevations are to be expected during winter months and have not yet been recorded. Groundwater levels have been measured manually in the standpipes (denoted S/P under the detail column). Equivalent groundwater levels have been correlated from hydrostatic pressure for the boreholes with VWP installed in them.

Plate 5 – Summer Groundwater Elevations (note: winter elevations are likely higher)

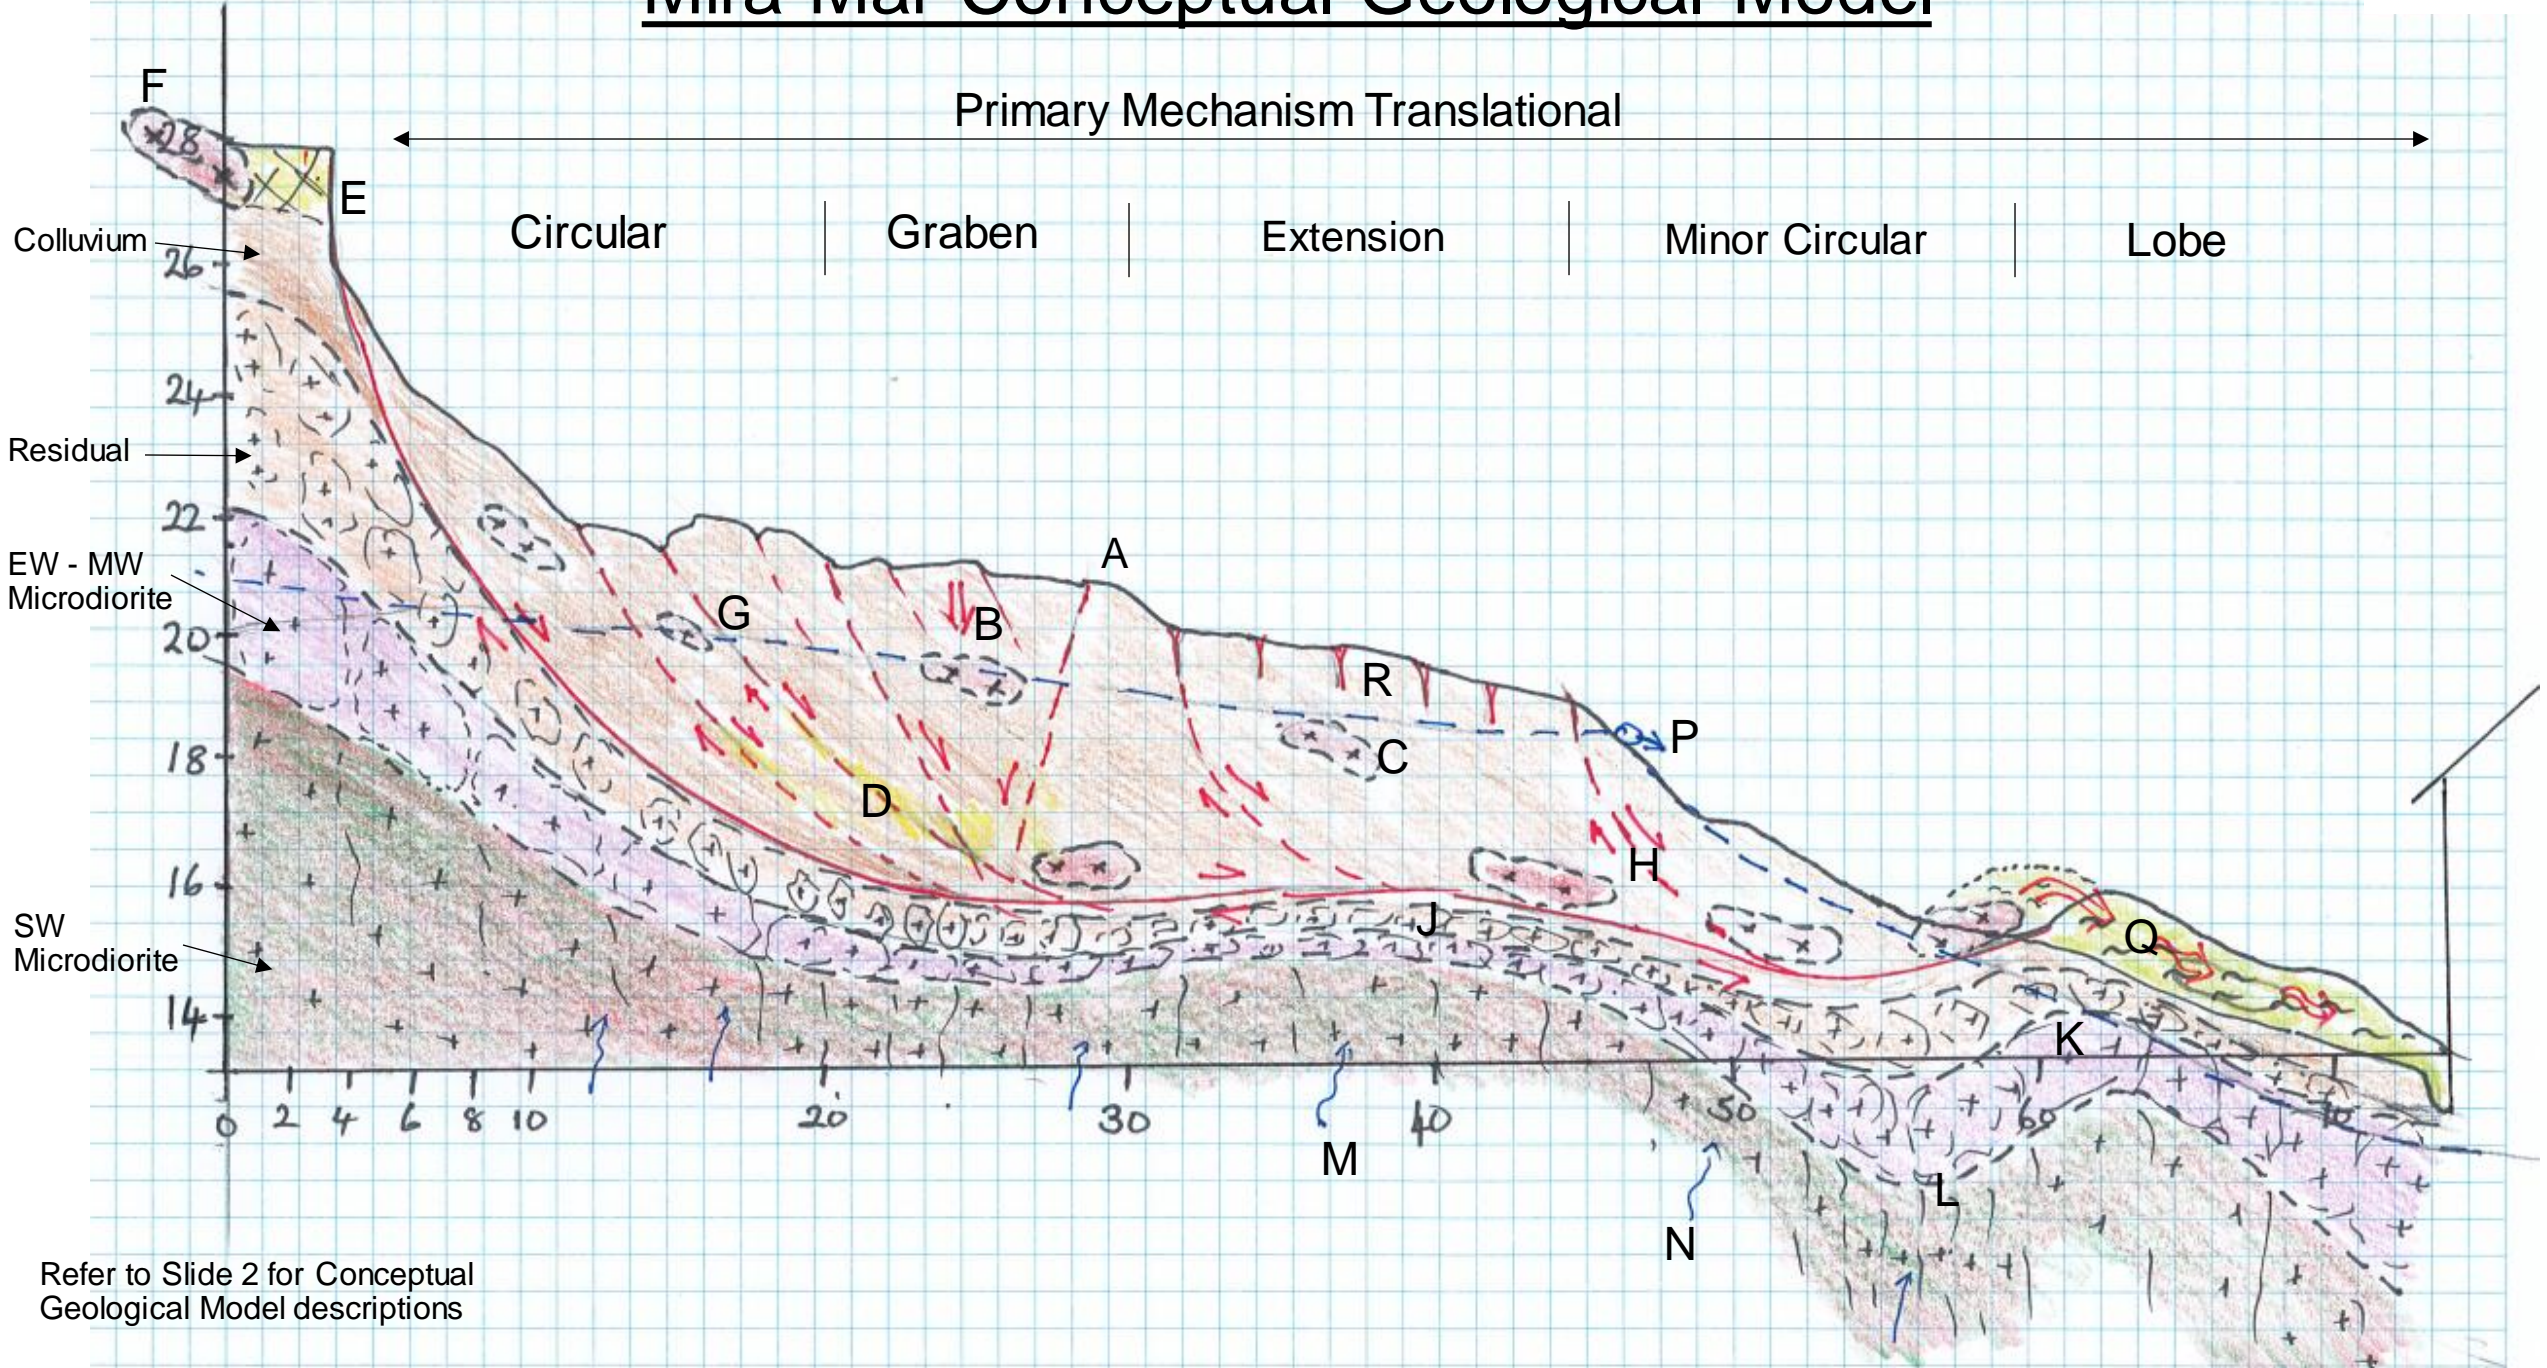
Mira Mar Conceptual Geological Model

No single slip surface can accommodate a landslide with the geometry observed and depicted in the attached Figure 2. As such it is necessary to have internal secondary slip surfaces (similar to those shown in Figure 2) and the result is a complex compound landslide. The crack morphology observed in late 2021 following the July/August landslide and observed and described in the CMW 2021 report supports the model shown in Figure 2, as do observations from the December 2022 boreholes. In particular, soft zones were noted in the area where the landslide geometry would tend to lead to voids (e.g., around D in Figure 2). At these locations very soft material and in some cases sand (inferred to be wash down from above) was observed.

- a) In the context of the relatively shallow slope gradients in the extension part of the slope (around R in Figure 2) high porewater pressures most likely initiated the 2021 failure and continue to be a main driving agent to instability.
- b) This area of the landslide corresponds to an area where a groundwater spring was present before the 2021 landslide occurred (refer P on Figure 2) and where piezometers installed in December 2022 show the piezometric surface is close to the ground surface despite the data being collected during summer months.
- c) It is thus inferred that the summer ground water levels are likely being fed in part from regional groundwater through a flow through the fracture rock mass. The groundwater

The key features of the conceptual model are recorded on the attached Figure 2 and have been used to direct and inform analyses present later in this report.

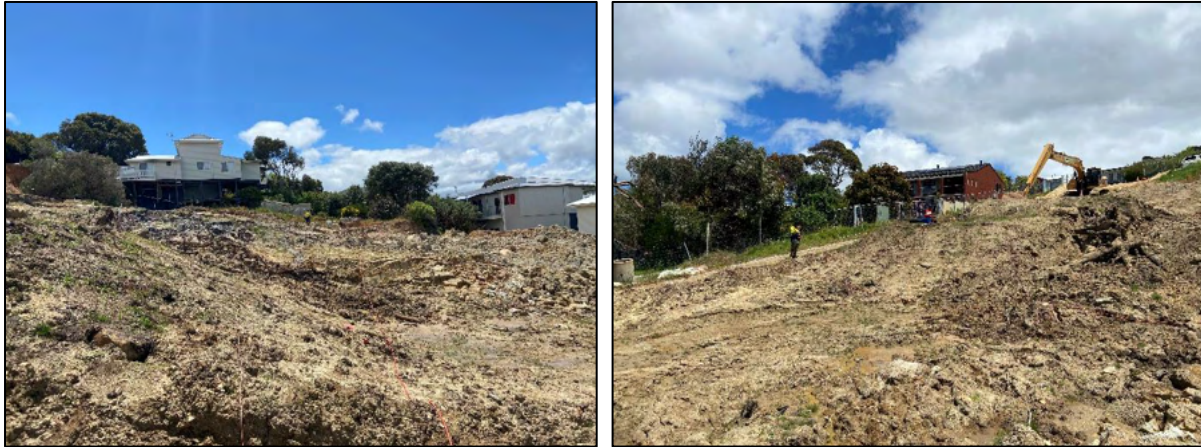
Surface conditions within the site were generally suitable for SRT and ERT data acquisition and consisted of cleared ground with wet clay and granite boulders, and debris from the demolition of the buildings previously occupying the site. Topography was decreasing to the south-east (perpendicular to Sleeman Ave) with a slope of approximately 1:6. Photographs showing the typical site conditions are shown in Figure 2.

Figure 2: Typical site conditions within the geophysical investigation area.

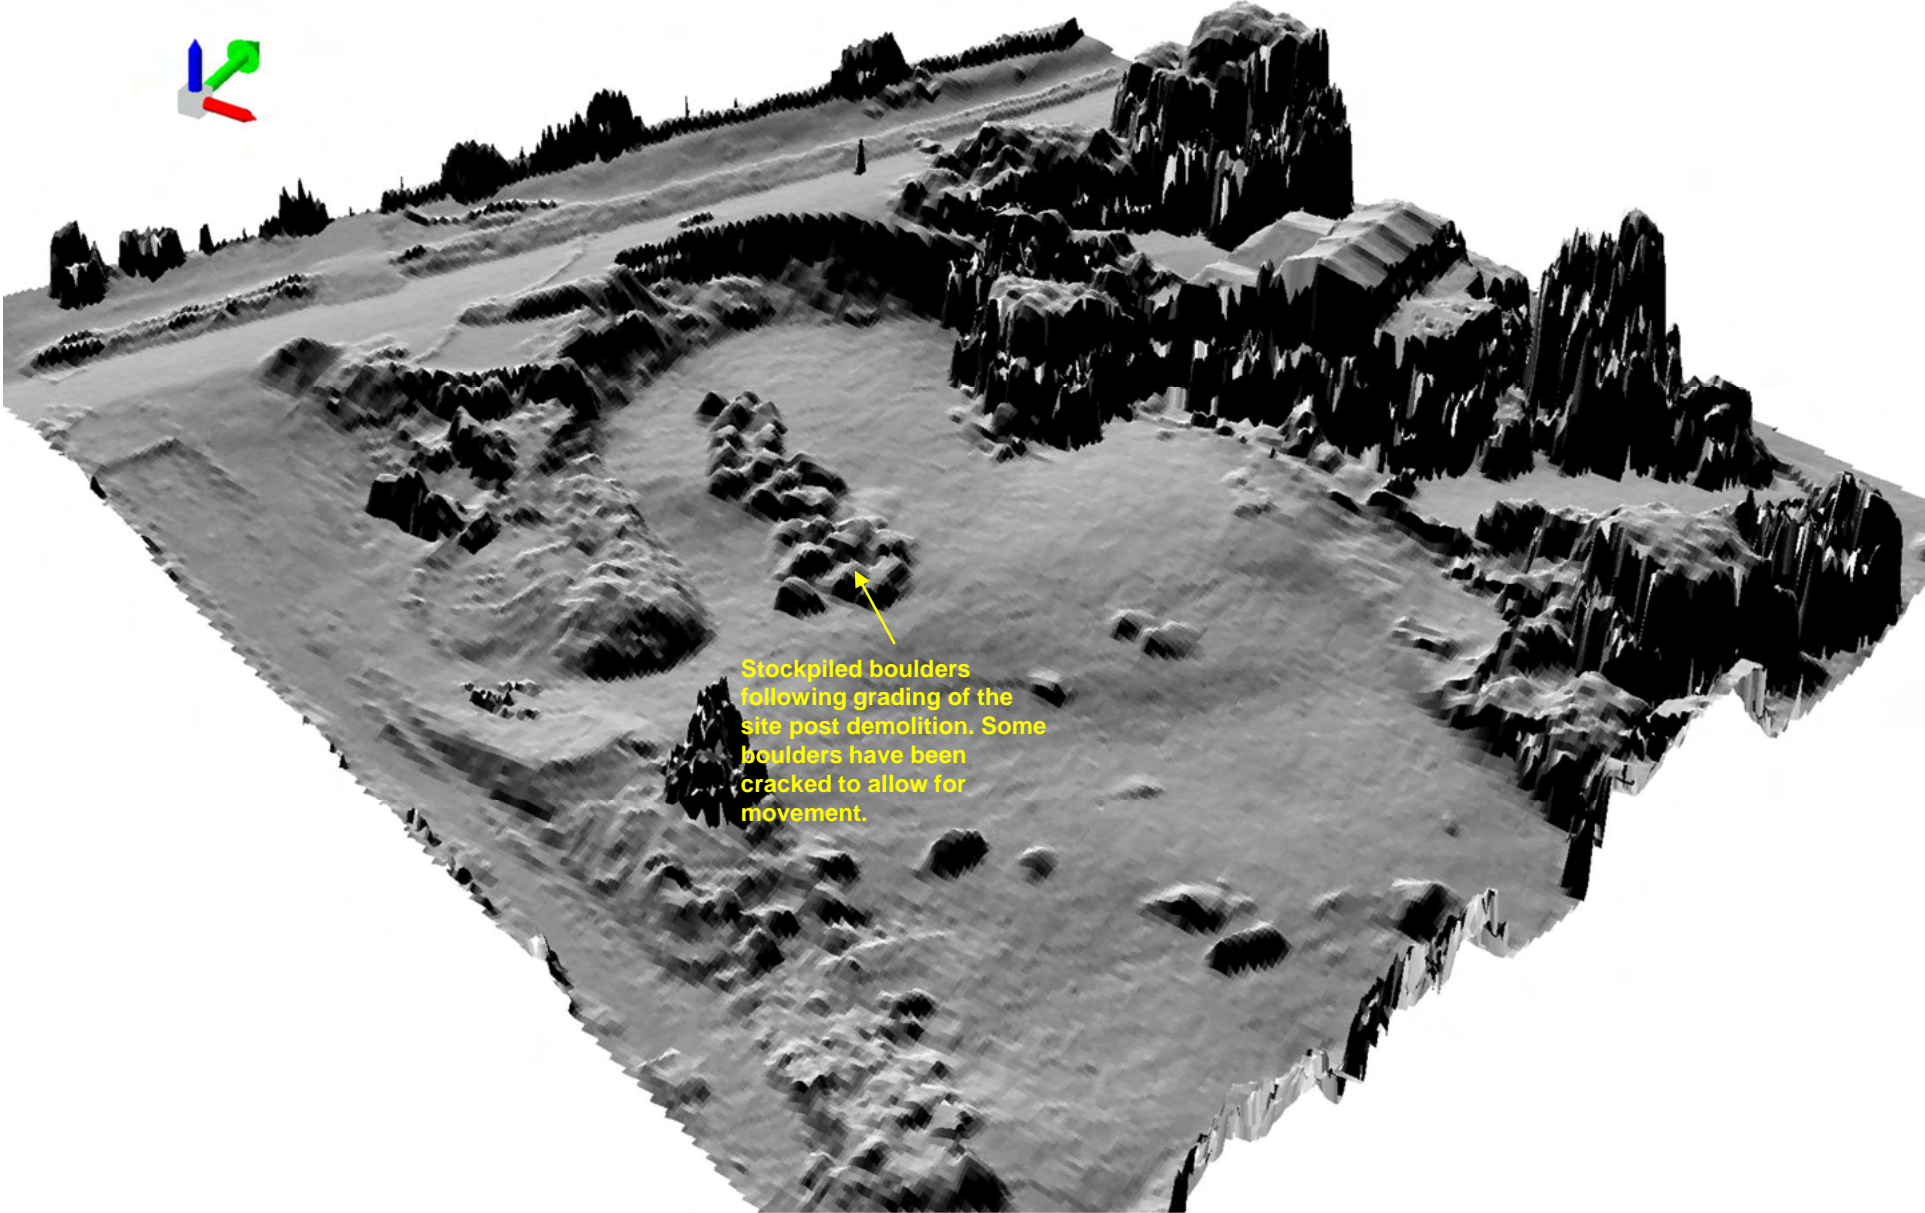
Survey Date: 9 June 2022

Stockpiled boulders following grading of the site post demolition. Some boulders have been cracked to allow for movement.
