GEOTECHNICAL INTERPRETIVE REPORT

MIRA MAR LANDSLIDE

**SLEEMAN AVE AND ANZAC ROAD MIRA MAR
WESTERN AUSTRALIA**

PER2021-0347AM

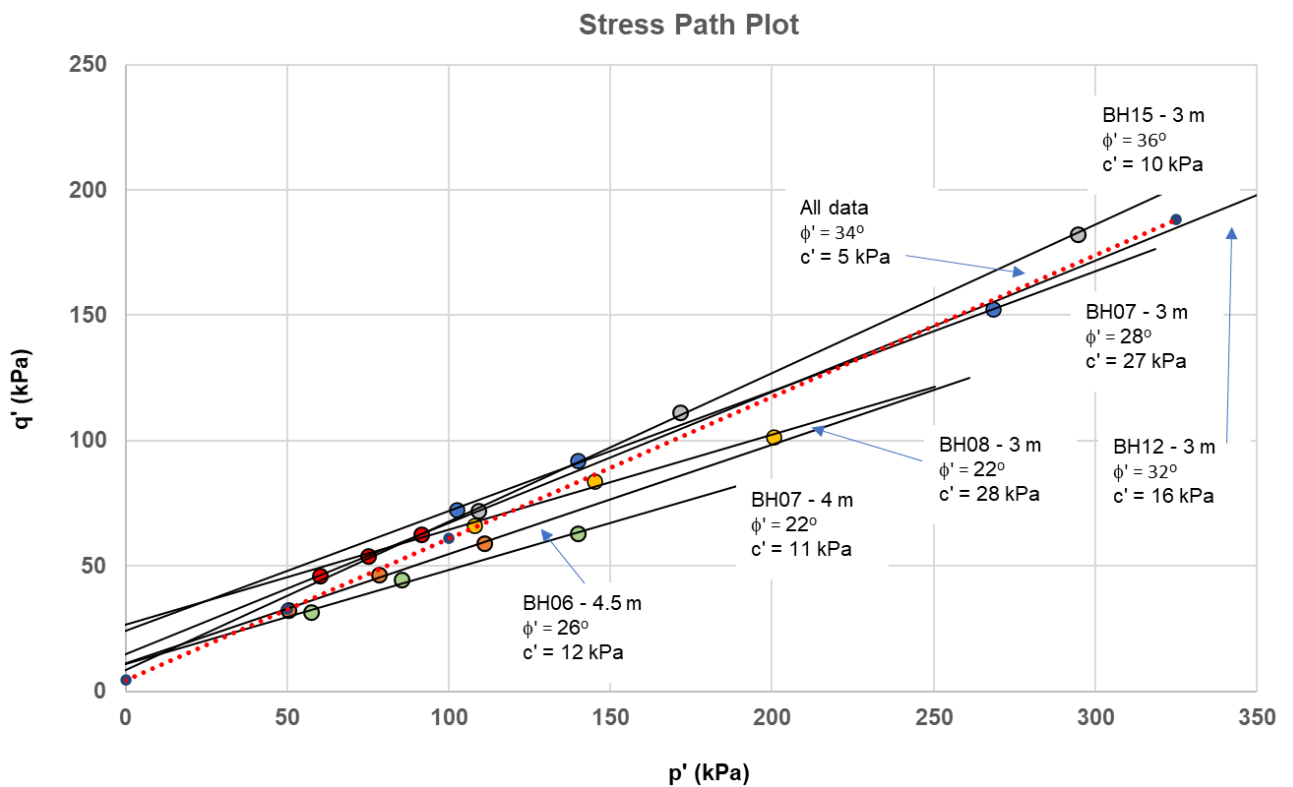
Plate 11 - Stress path plot (peak strengths)

The effective shear strength parameters obtained from the triaxial tests are shown in Table 10. A stress path plot is shown on Plate 11.

Note that the effective strengths shown in Table 10 relate to peak shear strengths. Relatively high values of effective cohesions are observed (c' > 10 kPa).

If a combined data set is considered, using data points belonging to the colluvium and the residual soil unit, then an effective cohesion of 5 kPa and an effective friction angle of 34° is obtained (refer to Plate 11, all data line).

Back-analysis of the slope, based on the February 2023 slope geometry and corresponding groundwater levels, revealed that the mobilised effective shear strength within the mobile zone would need to be significantly lower than that measured in the suite of triaxial tests (Plate 11).

To achieve a factor of safety of one, the mobilised friction angle in the colluvium is about 15° while the adopted effective cohesion is zero. These parameters are roughly half of those considered to be peak shear strength parameters as recorded in the triaxial tests. The values used in the back analyses are residual shear strength parameters and are considered applicable when assessing the current landslide and remedial works to stabilise the landslide. These parameters are not considered to be applicable for areas of first-time shear, for instance for propagation of the landslide upslope of the escarpment.

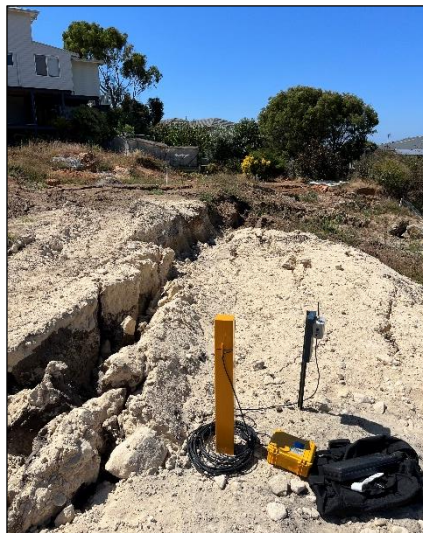
Plate 13 - Photograph taken at BH08 during February 2023

Given the degree of movement displayed on the landslide area, since the July/August 2021 landslide, and the observation that, even in summer, movement is still active (refer Plate 13) movement of the landslide is likely to remain ongoing until remedial works can improve the stability.

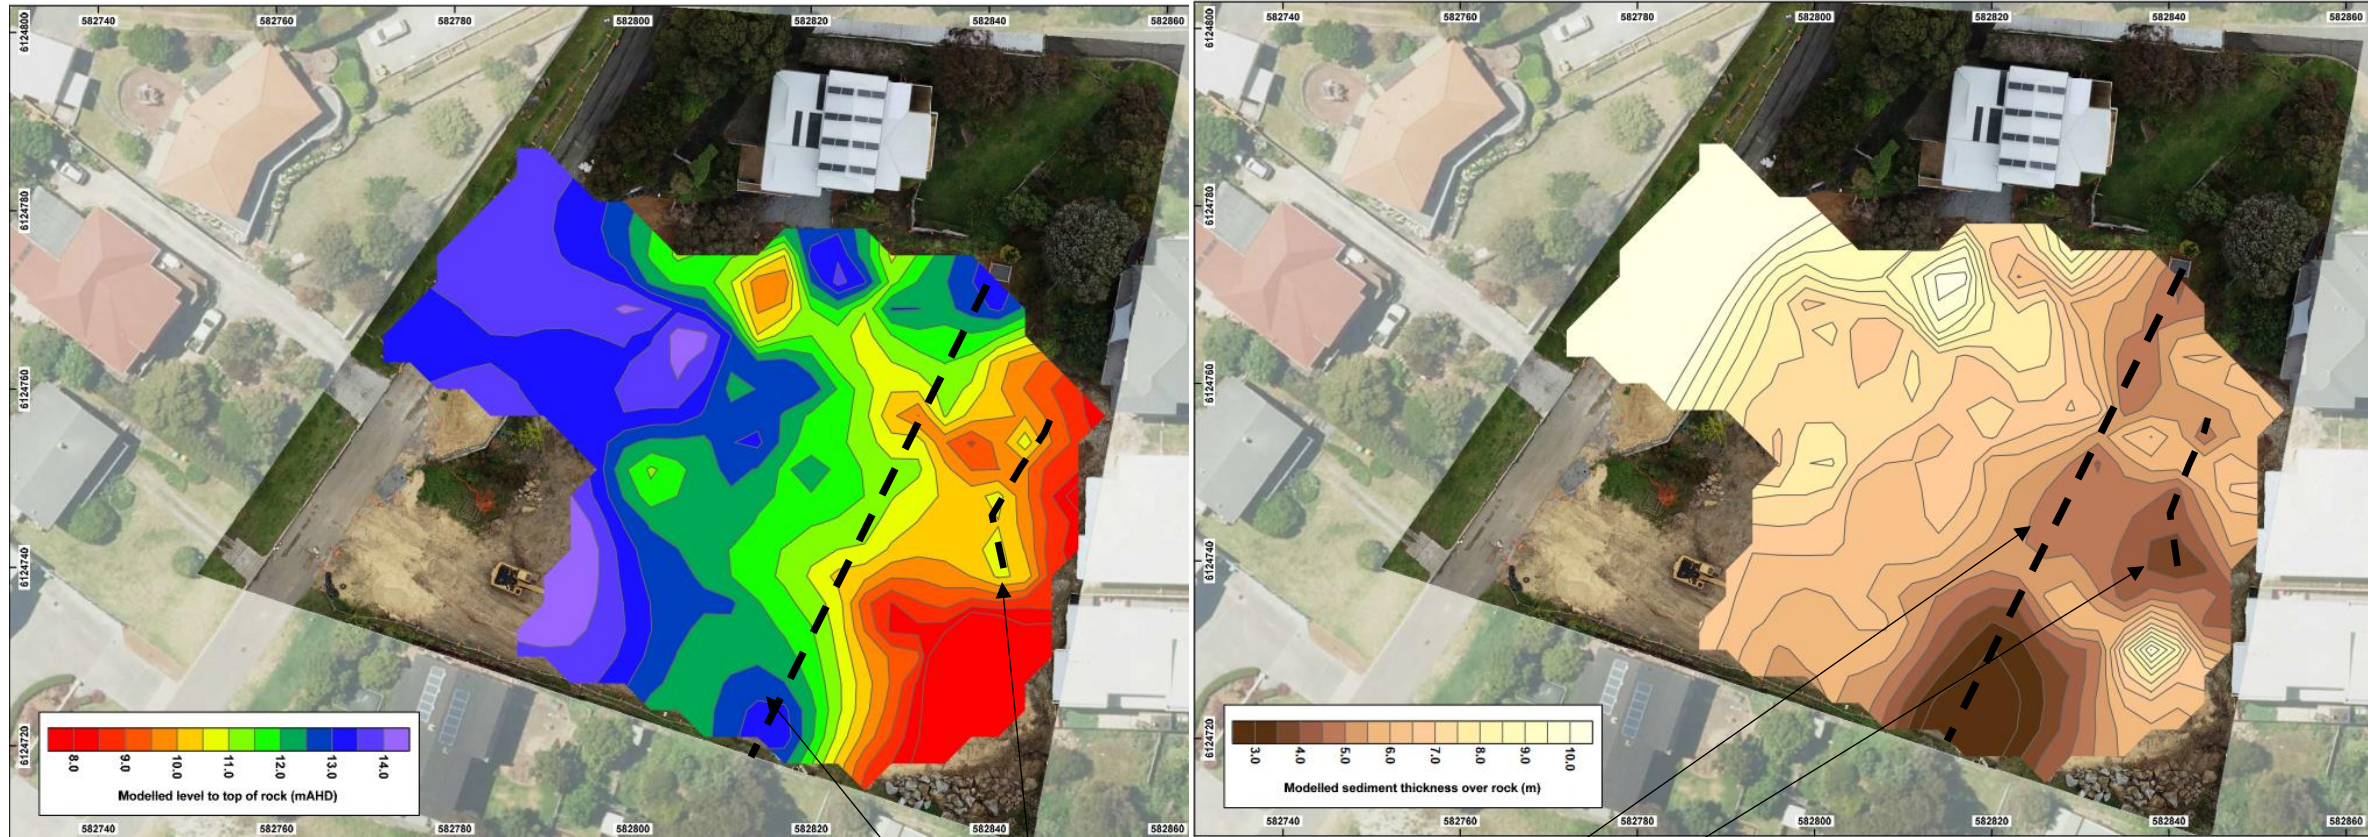
Figure 3 – Ridges in Bedrock surface depicted from geophysics

One key feature of the conceptual model is a potential increase in the elevation of the rock surface towards the eastern part of the site. This rise in rock level was detected by the geophysics (refer Appendix B and Figure 3). It was also inferred from the morphology of the original landslide, whereby it appears that a subsurface profile of harder ground appears to have influenced the form of the landslide.

R: Tension cracks previous observed in this area infer a zone of extension which matches with the rise in bedrock surface and areas of high groundwater (relative to ground level).

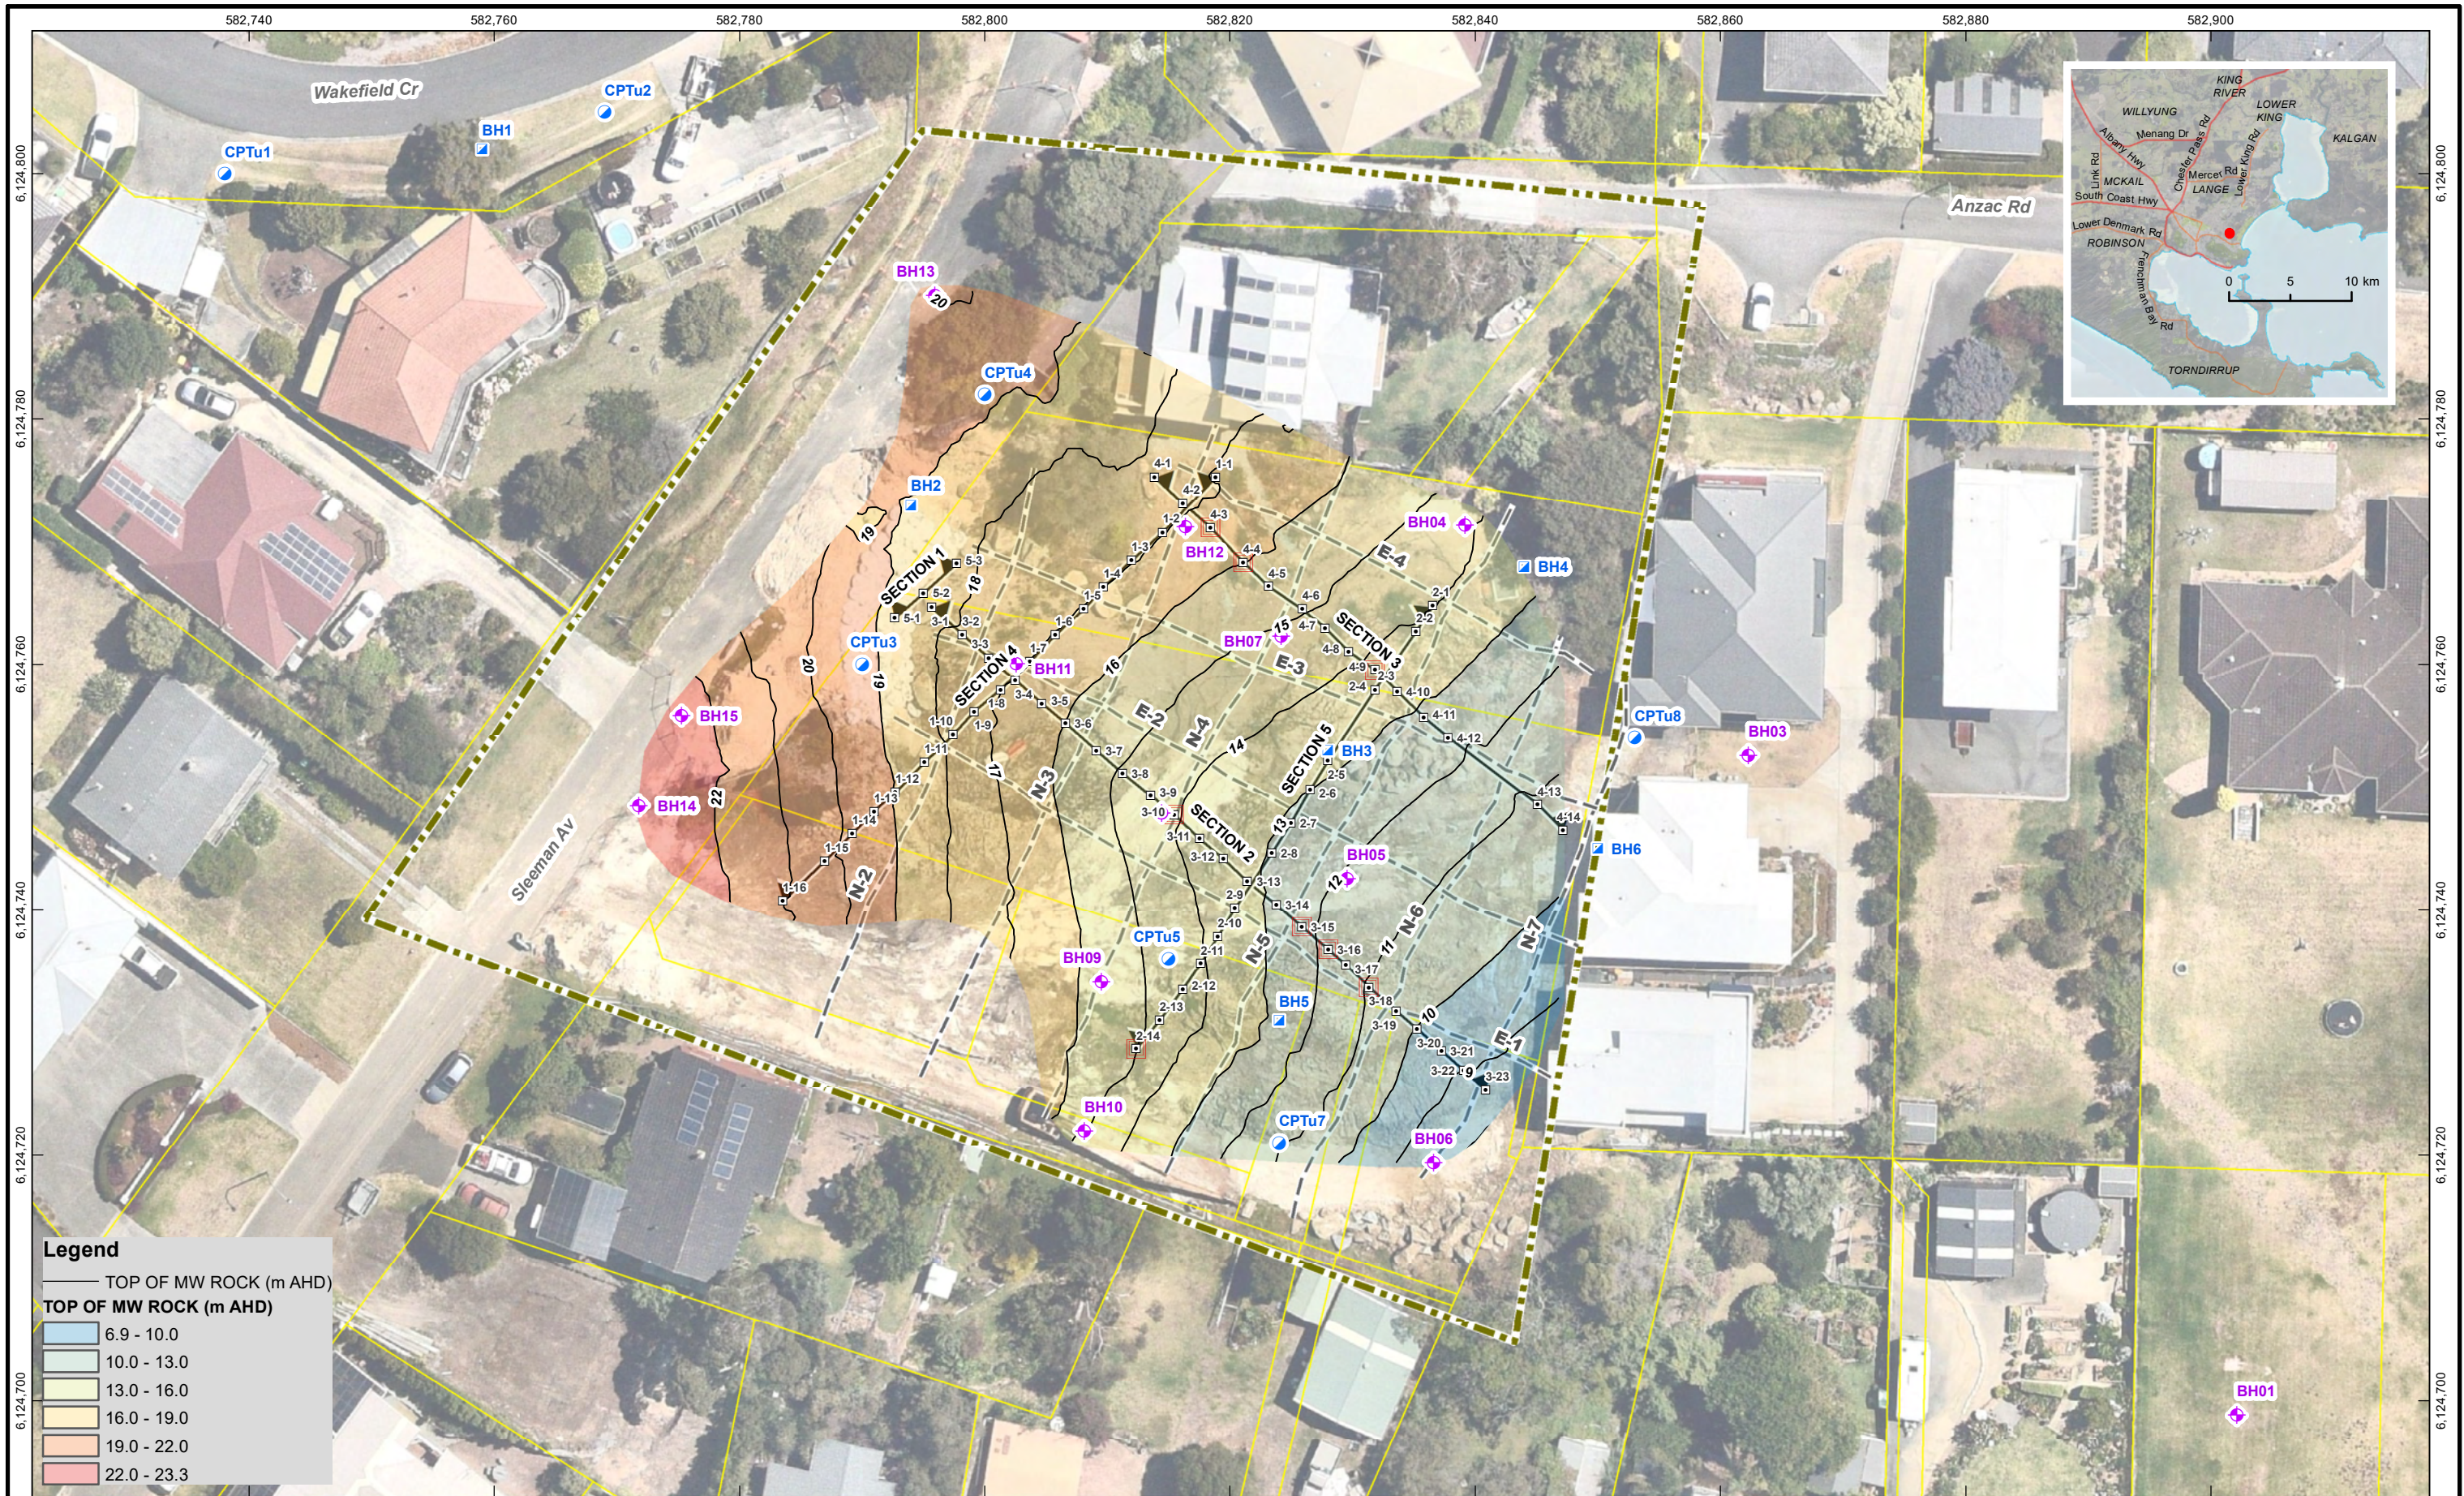
CLIENT: GREAT SOUTHERN DEVELOPMENT COMMISSION	COMPILED: NR	PROJECT: PER2021-0347
PROJECT: SLEEMAN ROAD, ALBANY	CHECKED: MAT	FIGURE: 5
TITLE: SURFACE OF TOP OF ROCK	REVISION: C	SCALE: 1:500
	DATE: 5/04/2023	SHEET: A3 L

The northern and southern flanks of the landslide are shown through monthly LiDAR surveys (refer Appendix E). Figure 5 shows the refusal depth of DCPs (top of weathered rock/core stones/competent strata) and Figure 6 (inferred top of residual soil) both shown that the landslide is located over a shallow valley shaped depression in the rockhead. It is estimated, from the contours represented on Figure 5, that this depression is up to about 3 m deep. This subsurface profile seems to have had some level of control in not allowing the landslide to develop significantly laterally (refer

There is some indication that localised areas of higher-than-average rock head might be controlling the landslide morphology with the current landslide appearing to daylight about 10 m west/upslope of the house at 7B and 7C Anzac Road. These areas of higher rockhead are not apparent from the DCP data (Figure 5) but crack patterns and compression features from the landslide study undertaken in Spring 2021 (CMW 2021) indicate a level of resistance to movement immediately to the west of 7A Anzac Road.

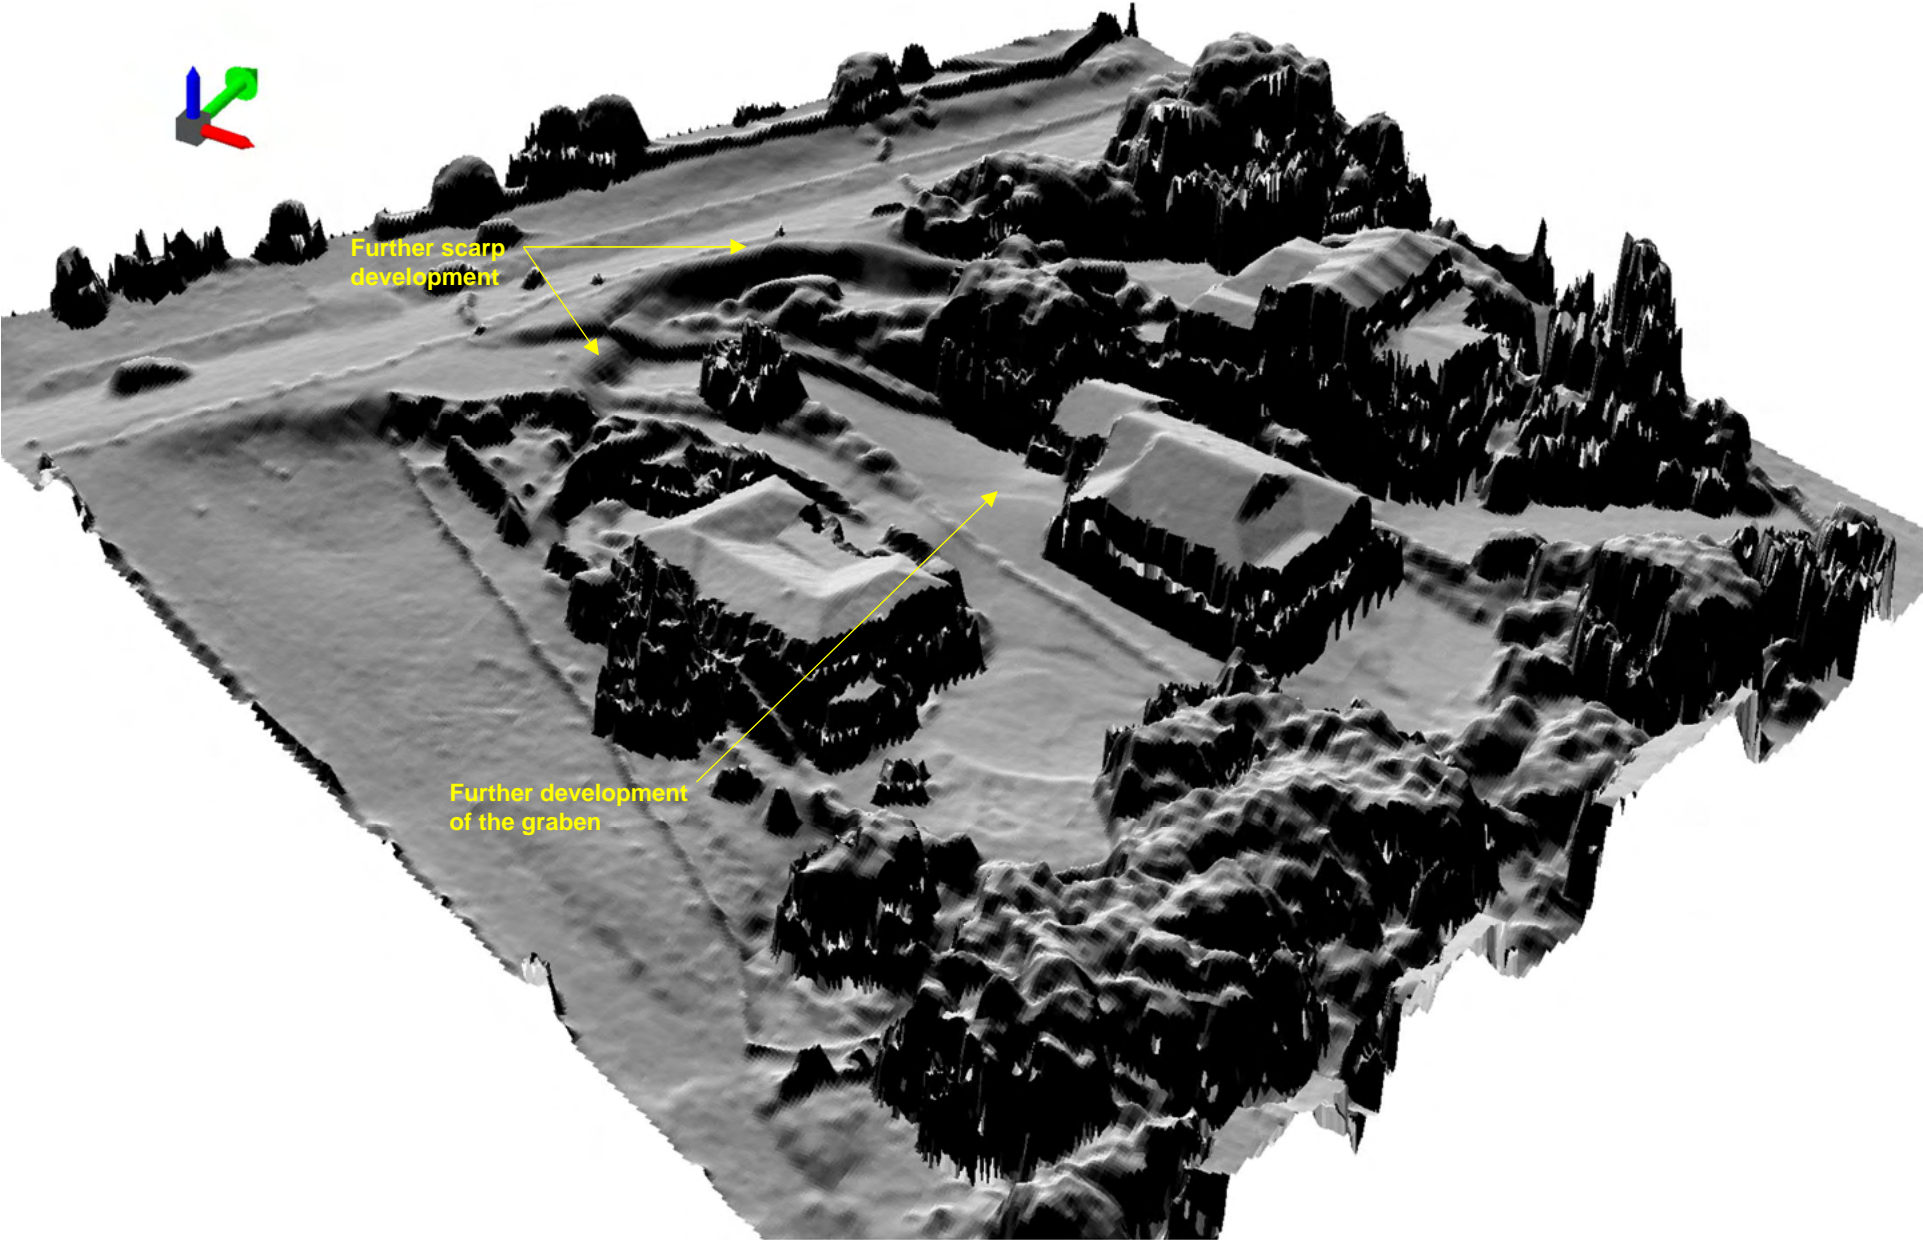
Survey Date: 5 October 2021

Further scarp development

Further development of the graben

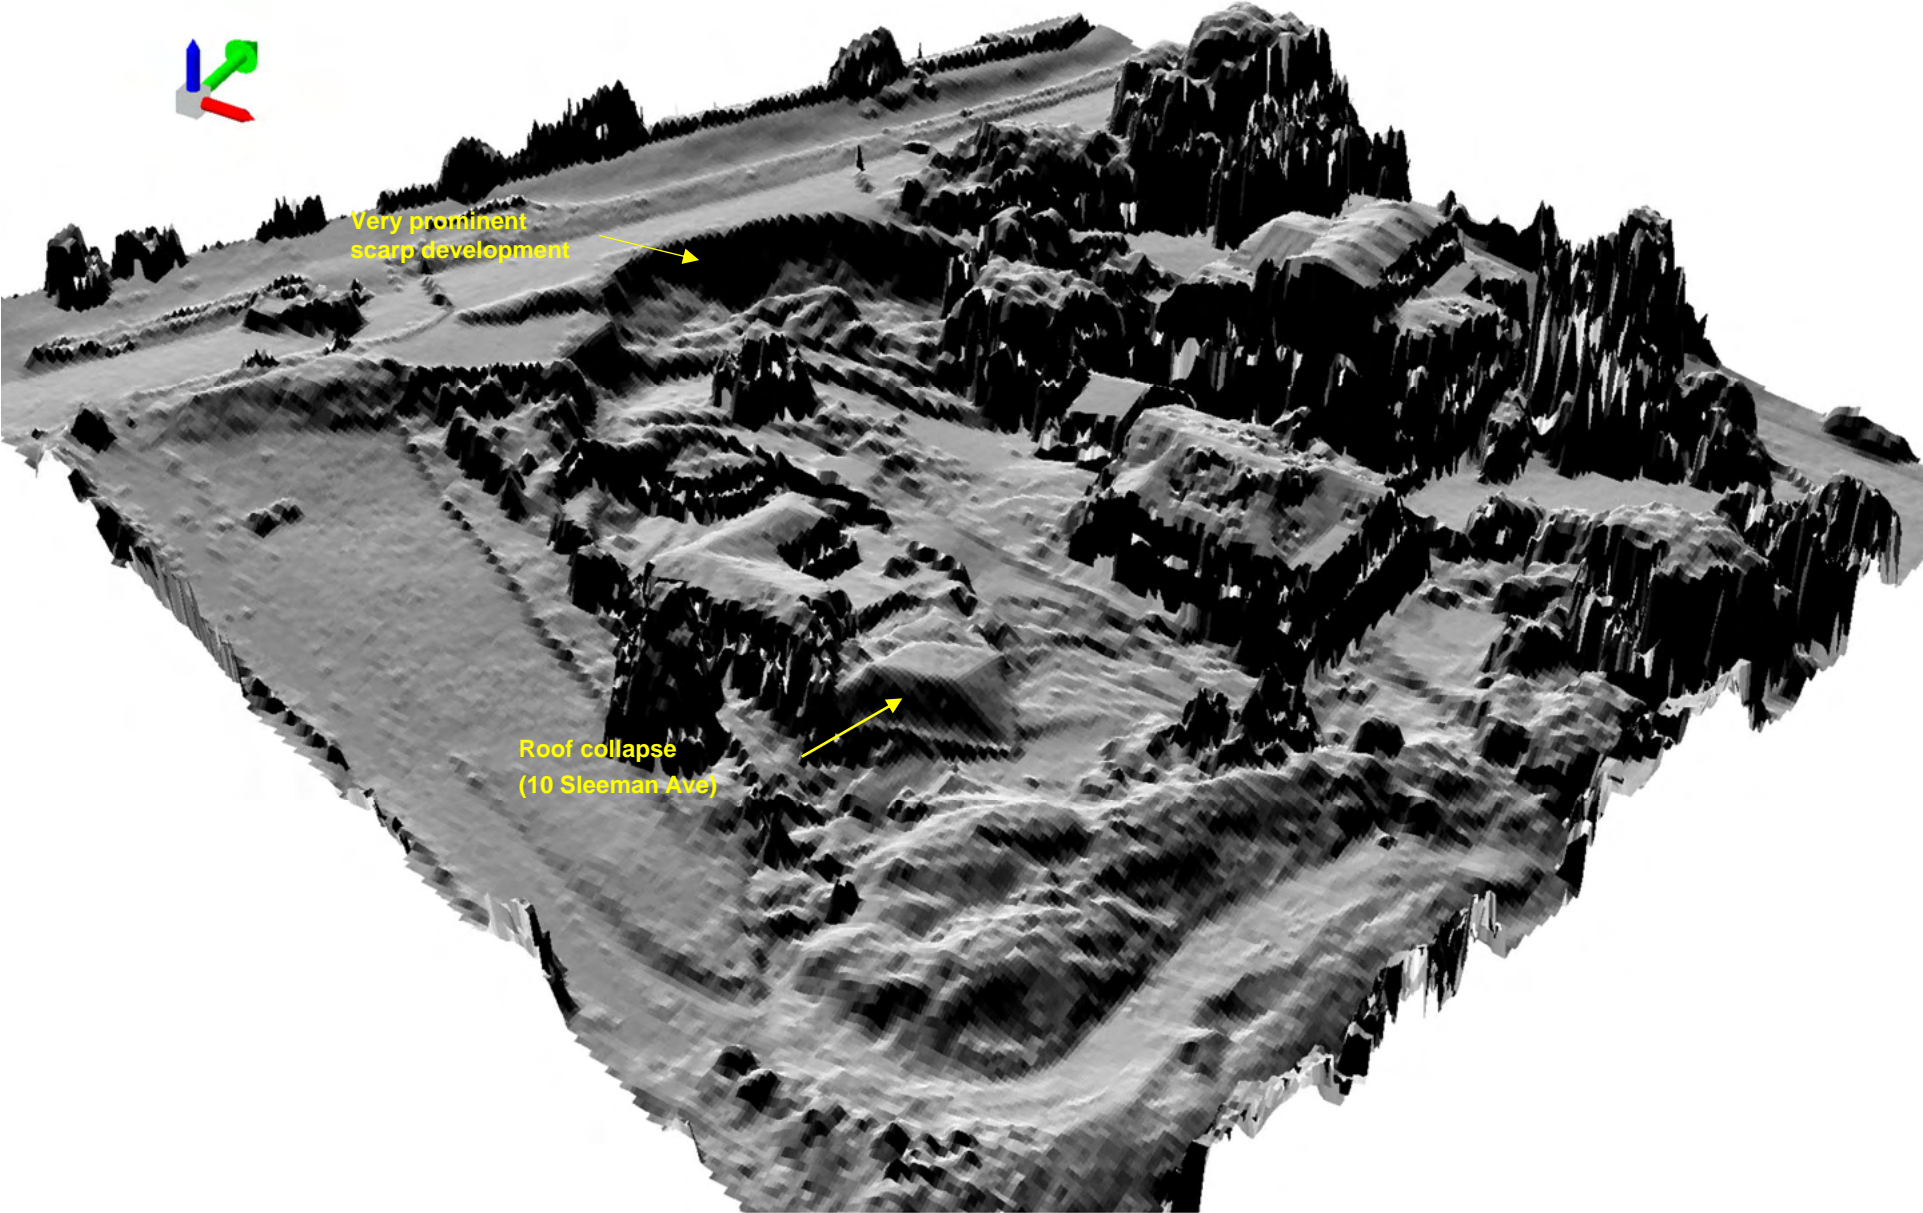
Survey Date: 29 April 2022

Very prominent scarp development

Roof collapse (10 Sleeman Ave)

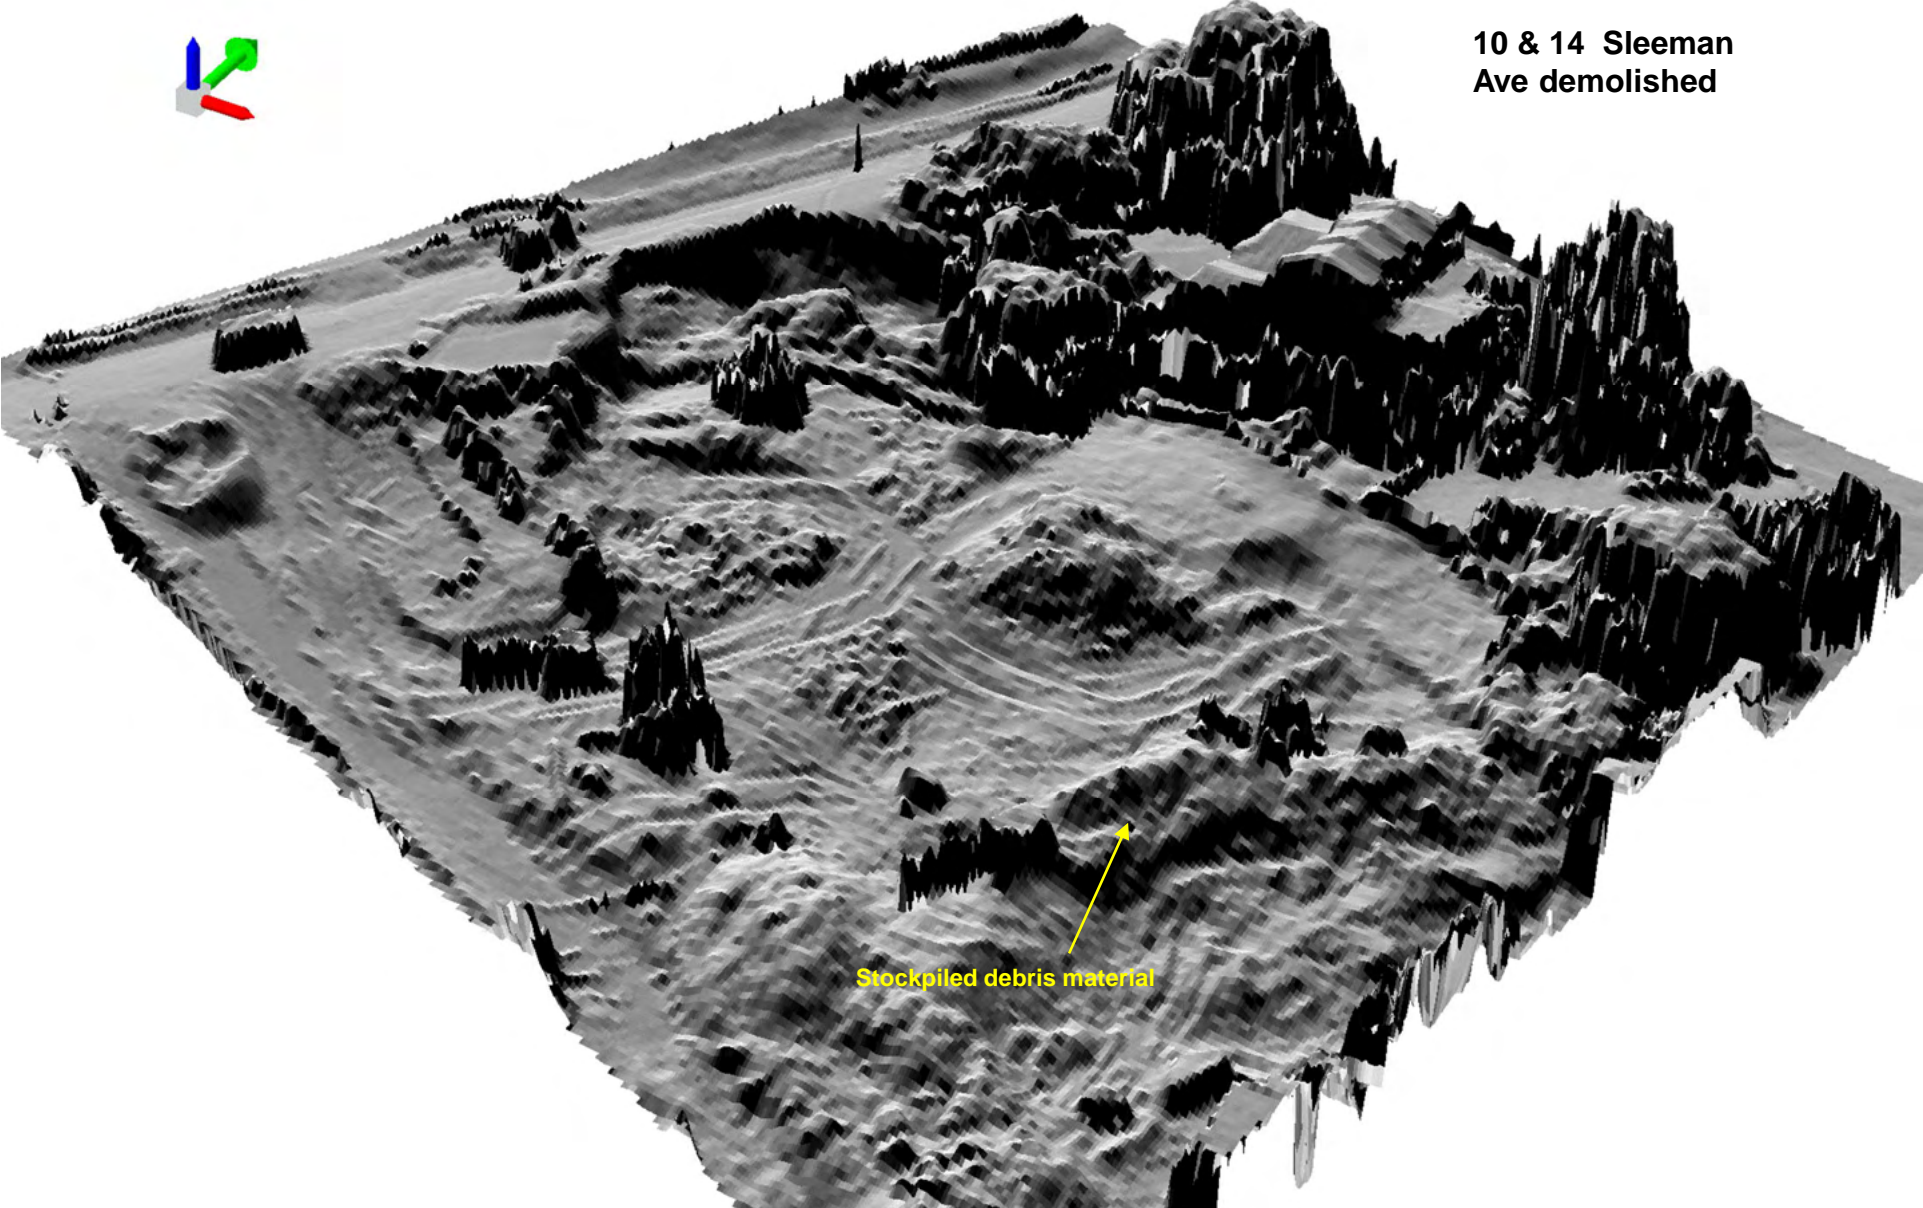
10 & 14 Sleeman Ave demolished

Stockpiled debris material

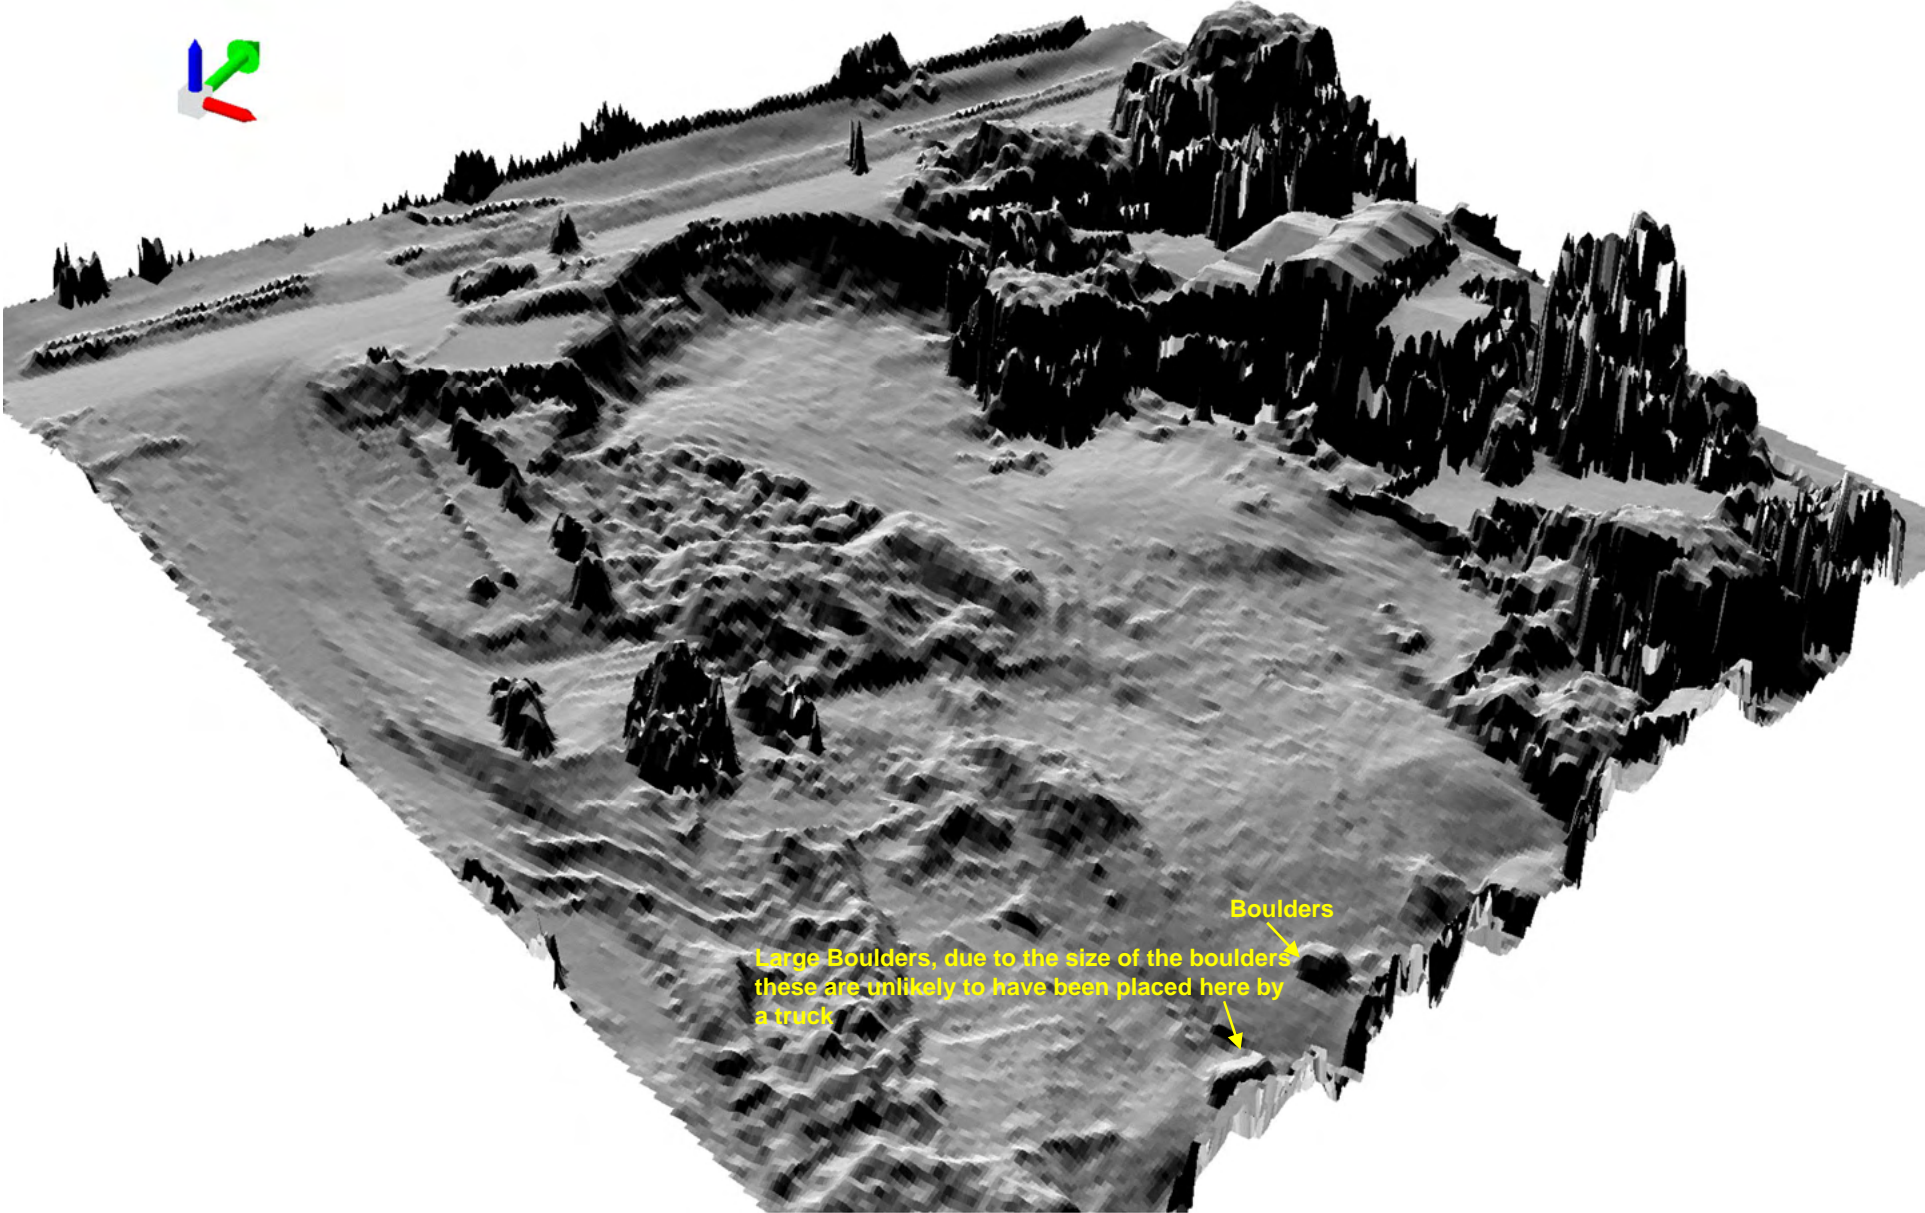
Survey Date: 25 May 2022

Boulders

Large Boulders, due to the size of the boulders these are unlikely to have been placed here by a truck

Stockpiled boulders following grading of the site post demolition. Some boulders have been cracked to allow for movement.

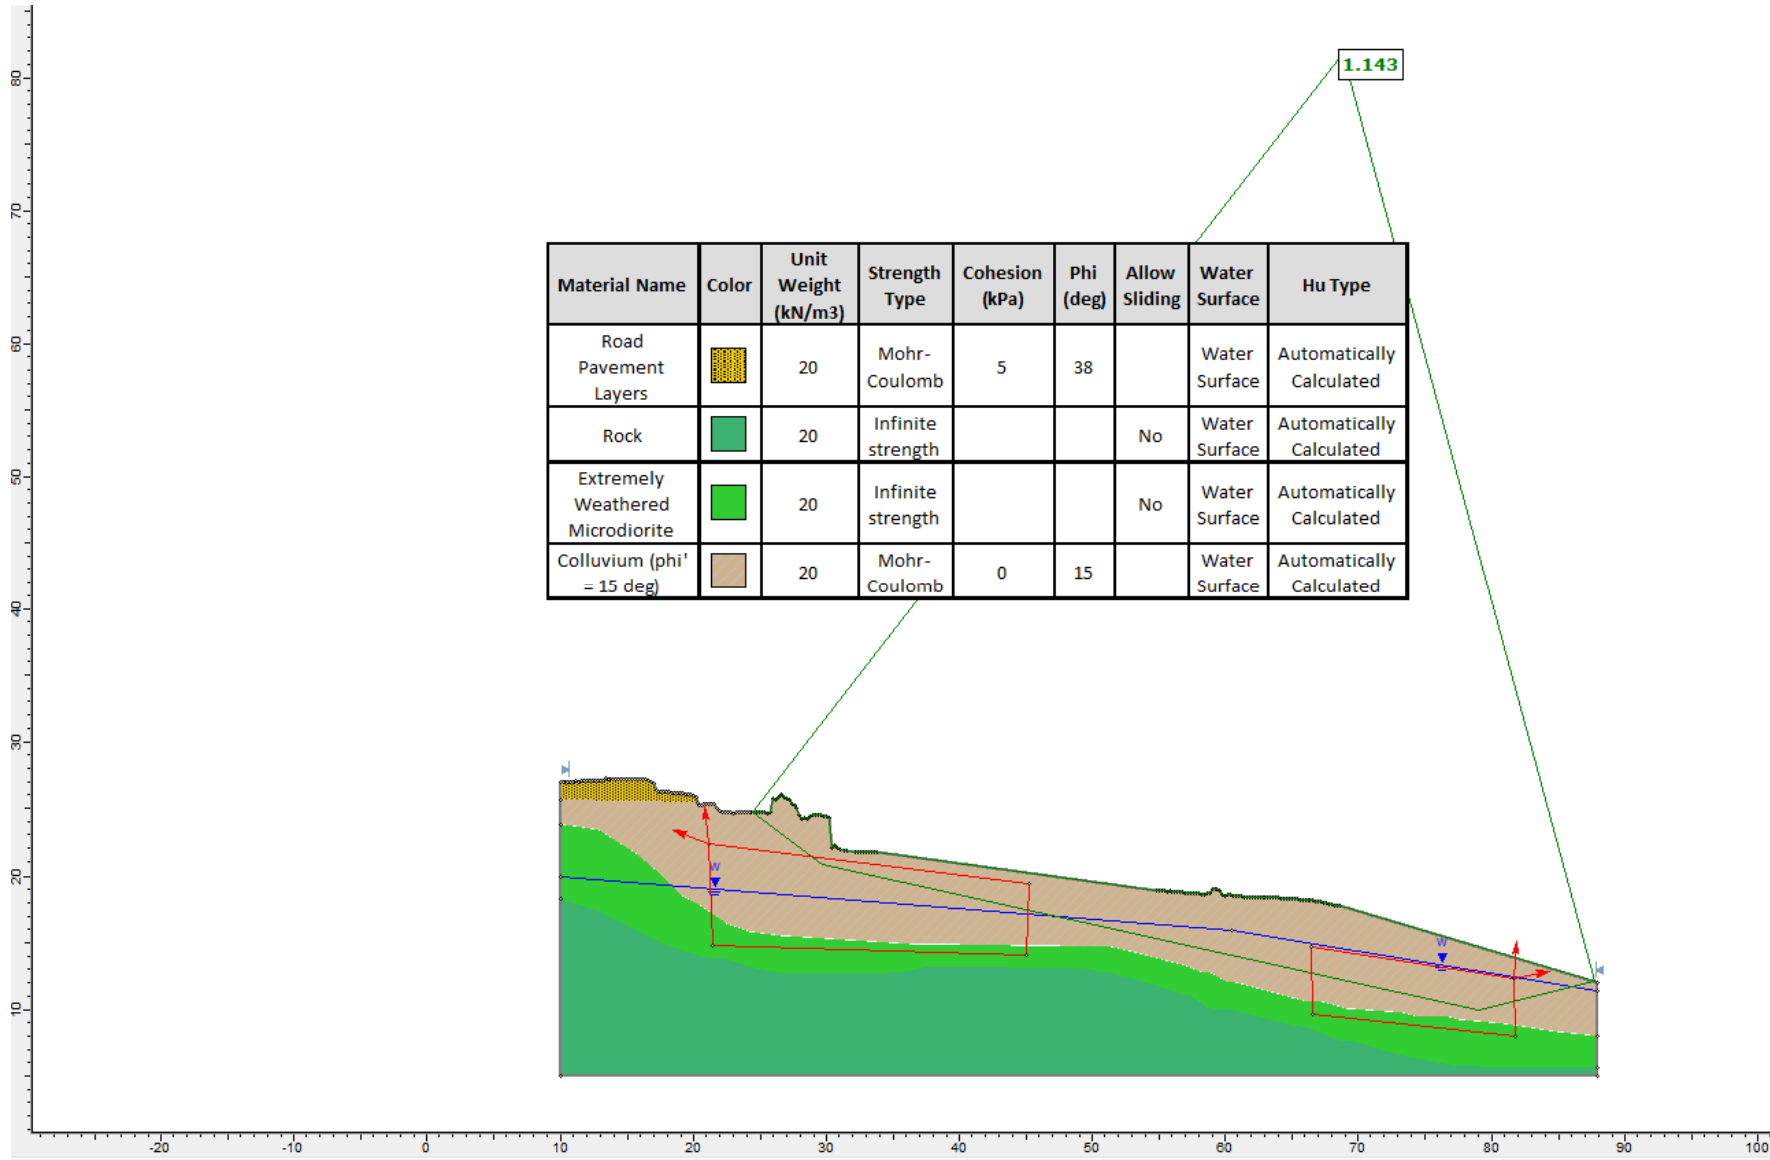
Analysis Case 4: September 2021 surface topography February 2023 groundwater level

Analysis based on back calculated residual values from Feb 2023 geometry – actual shear strength parameters likely higher at the time of the 2021 landslide before significant shear occurred.

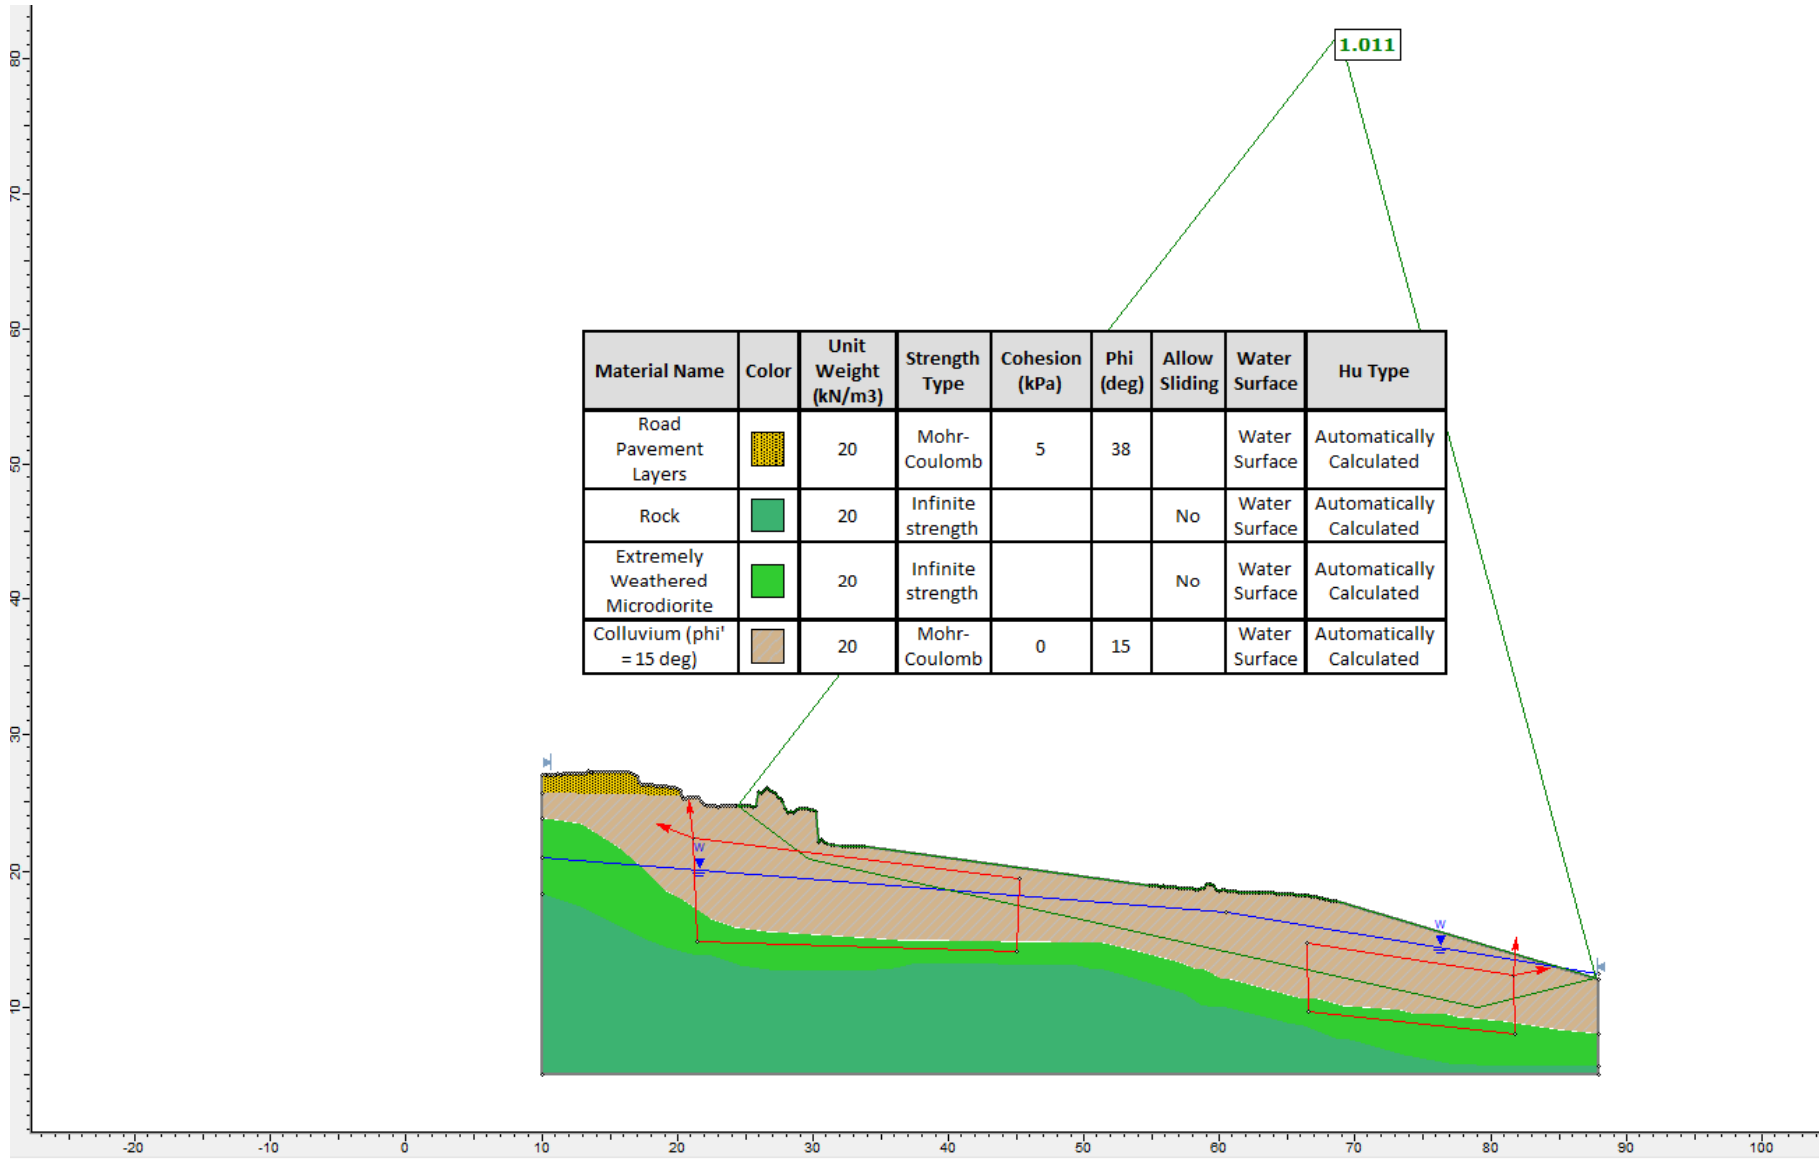
Analysis Case 5: September 2021 surface topography February 2023 groundwater level raised by 1 m

Analysis based on back calculated residual values from Feb 2023 geometry – actual shear strength parameters likely higher at the time of the 2021 landslide before significant shear occurred.
