GEOTECHNICAL INTERPRETIVE REPORT

MIRA MAR LANDSLIDE

**SLEEMAN AVE AND ANZAC ROAD MIRA MAR
WESTERN AUSTRALIA**

PER2021-0347AM

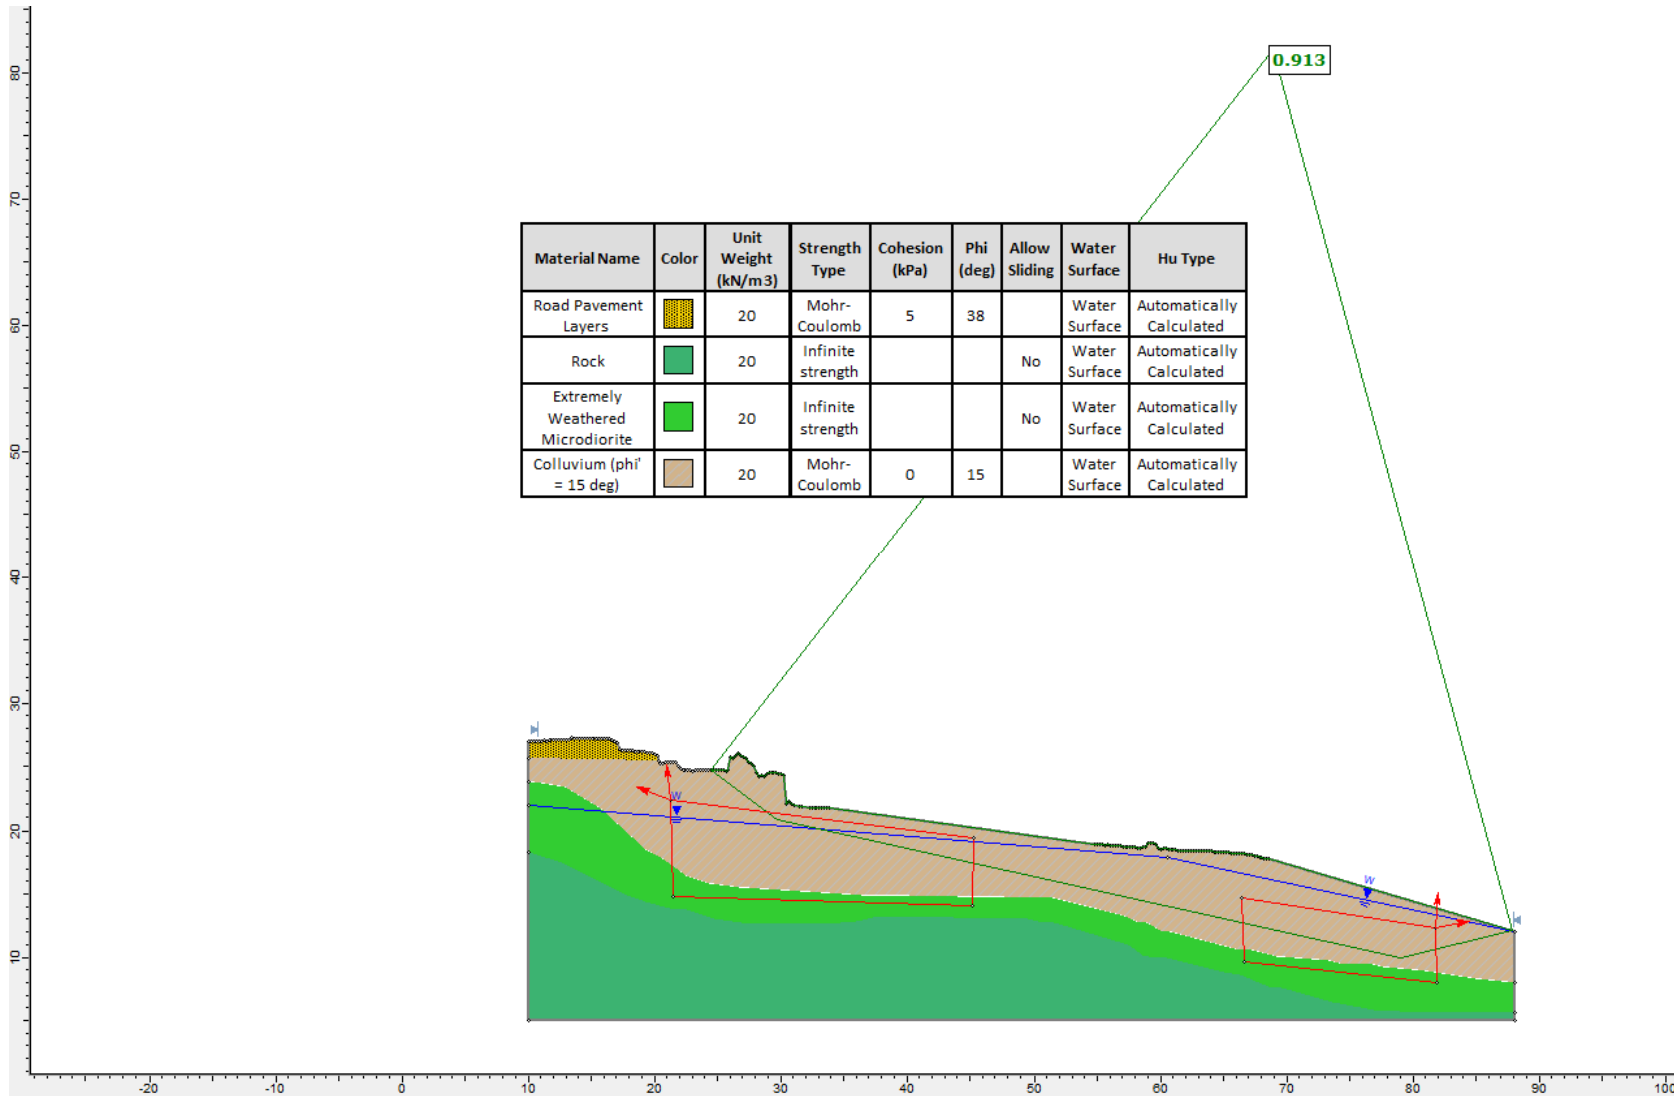
Analysis Case 6: September 2021 surface topography February 2023 groundwater level raised by 2 m

Analysis based on back calculated residual values from Feb 2023 geometry – actual shear strength parameters likely higher at the time of the 2021 landslide before significant shear occurred.
